Mobile Intel[®] Pentium[®] II Processor Specification Update

Release Date: March 2006

Order Number: 243887-051

The Mobile Pentium[®] II processor may contain design defects or errors known as errata which may cause the product to deviate from published specifications. Current characterized errata are documented in this Specification Update.

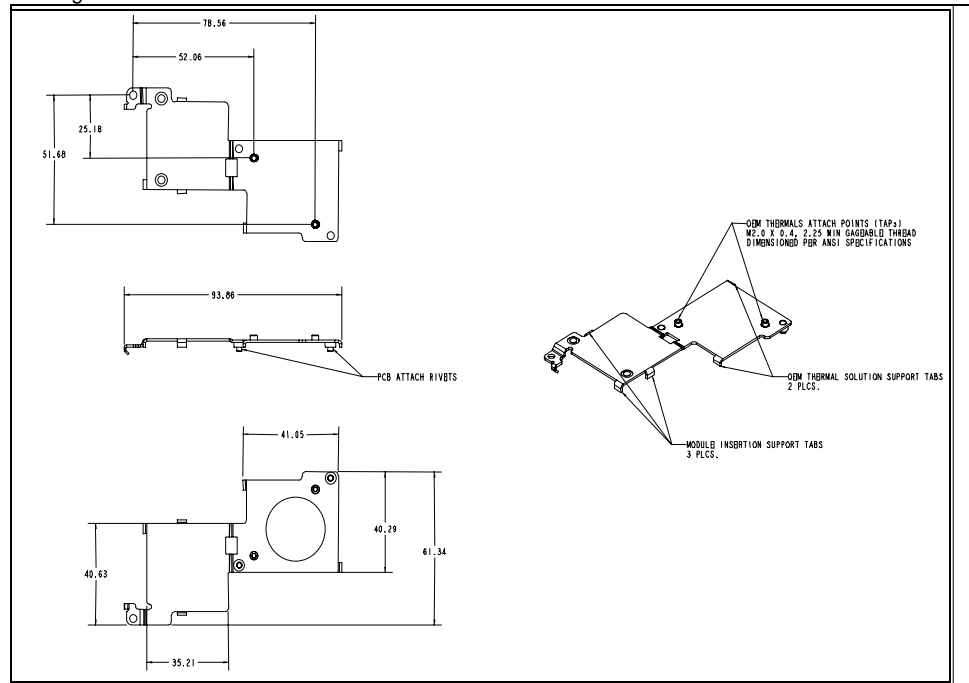
Figure 1. TAP Gageable Thread Clarification

OEM Thermal Attach Points (TAPs) M2.0 x 0.4, 2.25 min gageable thread dimensioned per ANSI specification.

See Figure 1 below for more information.
